Owner Notification Program
ONP 2007-02

November 20, 2007

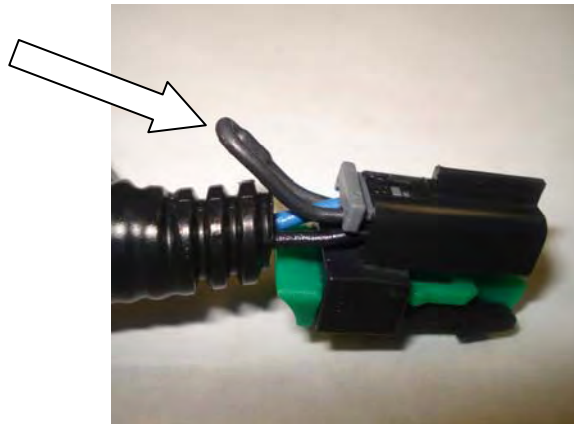
Some Chevy 560 (C4500-C5500 Kodiak) vehicles have been found to exhibit extreme (up to 175V) voltage spikes during engine cranking. These extreme spikes can damage the diode in the ILIS605-H3 Harness near the shift lock solenoid connector. If the diode fails in a shorted condition, the Gateway 401 module can be damaged. If this occurs, the shift lock solenoid may not engage.

If **all** of the above criteria are met, inspect the ILIS605-H3 Activation Harness to determine if further action is required. This harness is attached to the shift lock solenoid under the steering column. Inspect at the solenoid connector for the presence of a jumper going from the blue wire to the black wire. This is the diode. It may be necessary to pull back the plastic conduit to get a better view. See photo.

If there is no diode present, the vehicle is not affected by this notification. If there is a diode present, proceed with this Owner Notification Program.

- Set parking brake, turn on ignition, and allow the Interlock display to prove out. Verify that the gear selector is locked and that you cannot shift out of Park. Release the parking brake. You should now be able to shift out of Park.
- If vehicle passes above test, contact InterMotive for a J01A1 Harness Kit. The kit comes with installation instructions and can be installed in about 5 minutes.
- If the vehicle did not lock the gear selector, contact InterMotive for a new Gateway Module and a J01A1 Harness Kit. **The J01A1 Harness must be properly installed prior to replacement of the new Gateway Module or the module may be damaged.**
