## Technical Service Bulletin

**TSB # T2006-02**

**Product:** Gateway AI

**Model #:** GTWY401-A1 Rev 1.0 and Rev 2.0

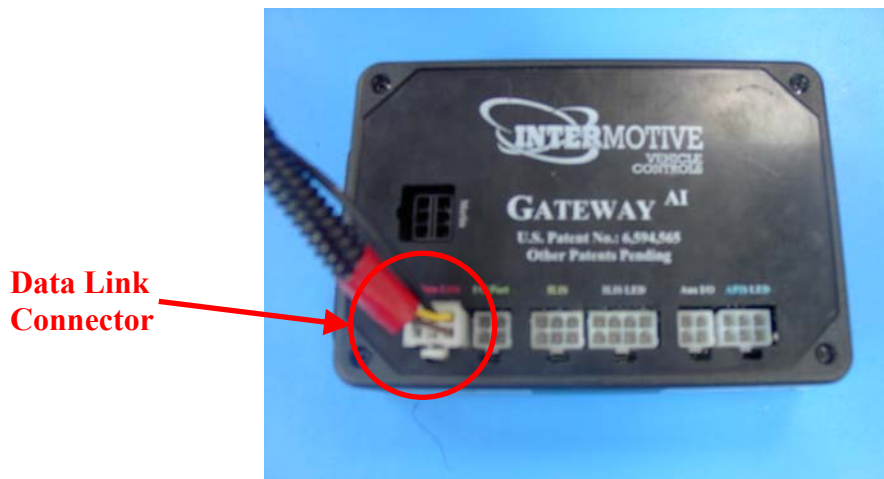
**Issue:** When the module transitions from its power down mode (ignition off) to its power up mode (ignition on) the module intermittently may not wake up. If this action occurs, the module's LED display panels will not prove-out and the backlights on the LED display panels will not illuminate.

**Action:** Disconnect and reconnect the data link connector on the module. The data link connector has red tape as its indicator. See picture below for a visual depiction of the data link connector.
