Technical Service Bulletin

TSB# T2007-03

Product: Merlin Multiplex System

Model# Merlin: Digital Power Center(s), Door Module and Dual Door Module

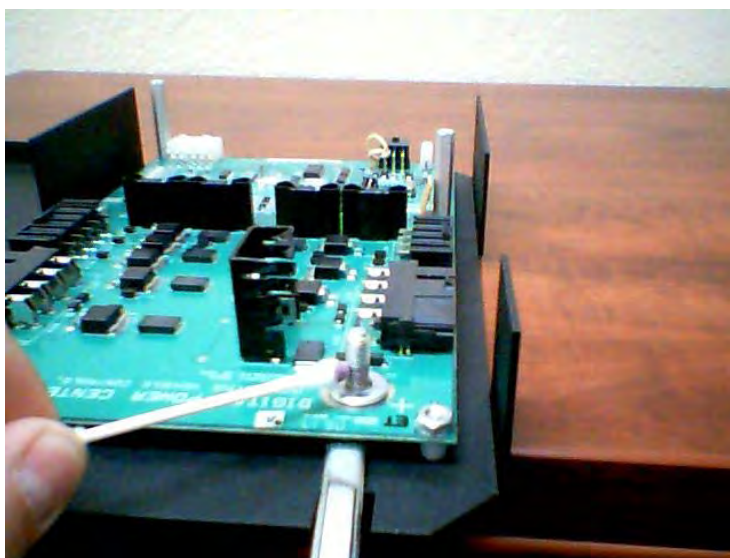
Issue: When a power/ ground lug is not correctly tightened or has become loose for any reason; erratic system operation is possible. This bulletin applies to all modules shipped prior to 9/10/2007.

1. Locate Digital Power Center(s) and perform side-to-side wiggle test to determine if any lugs have become loose.
2. **Disconnect vehicle battery.** Failure to disconnect battery may cause damage to the Digital Power Center(s).
3. Remove top cover from Digital Power Center(s) for access.
4. Remove both power and ground cable from Digital Power Center(s) using a 7/16 wrench.
5. Remove second nut and apply a small coat of Loctite 222® with a cotton swab. (See picture below).

Note: Do not cover entire bolt or washer and do not use Loctite 222® in areas that contact the circuit board.
